From the Sump

by Felix Furtak

We recently received a restored vehicle for minor trouble shooting. We just wanted to slot it in for a day or two amongst the other long time projects. The vehicle proved to be full of surprises:

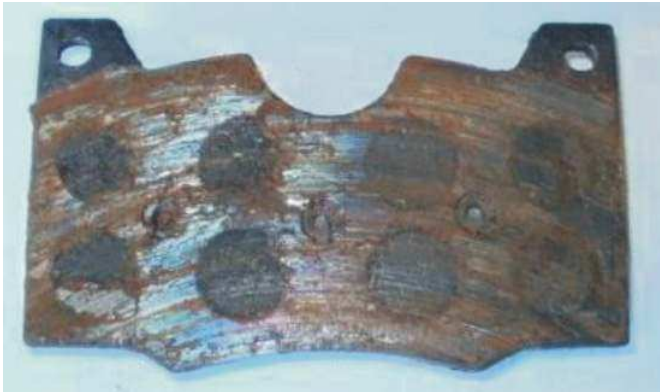
Above: *Here we can see that the pad was home-made clearly in an attempt to cut costs, corners, and maybe lives as well, but that is not enough, why do we see the grinding marks at the BACK of the pad, on the metal backing? Bingo...*

Above right: *Well spotted. The pad was fitted reversed, an absolute first by ALL standards. So far for the safety, now let us look at other design features, like the cabin vent design. Originally the car does not feature any cabin ventilation, a severe shortcoming that has finally been rectified:*

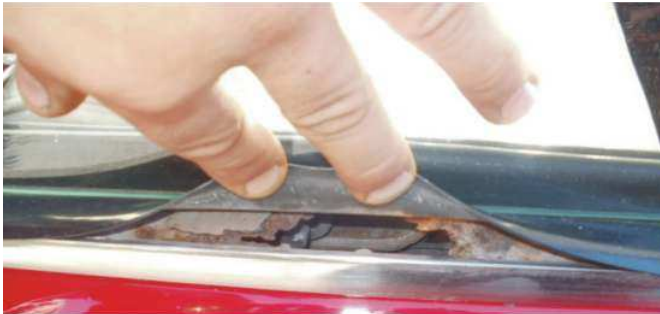
The beauty is that the rubber provides a valve effect, so pressurized air can escape the cabin, but not vice versa.

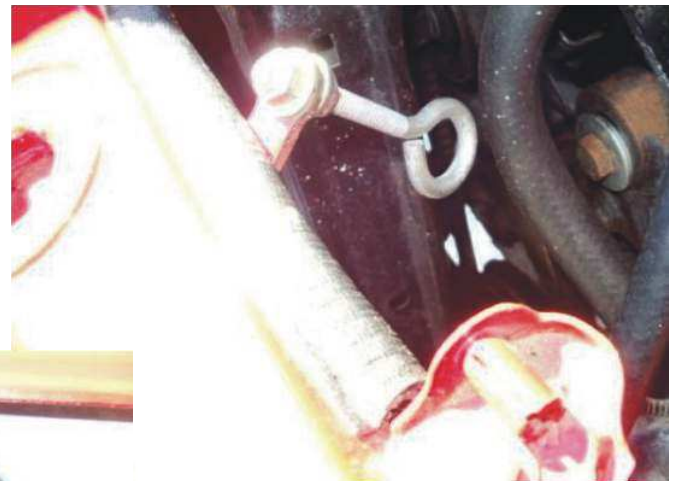
A common problem on cars is the bonnet cable, which can snap, leading to much unpleasantness. This is why per regulation competition cars need to have alternative solutions: Here we have a modified bonnet lock:

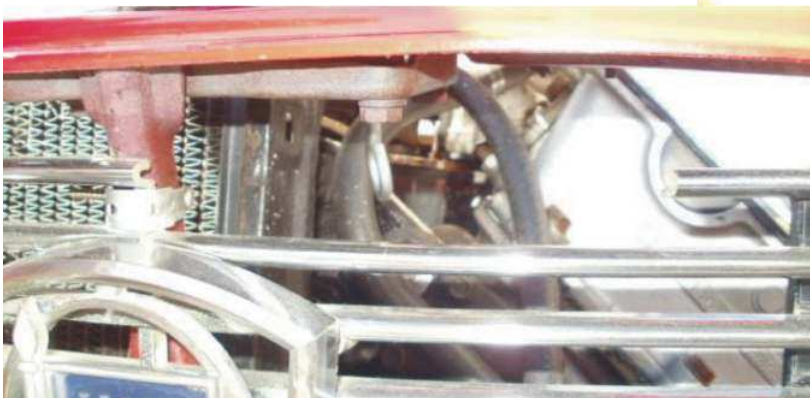
But now there is a "catch". How do we access the much improved lock? Here is the stroke of ingenuity:

Left: A simple cut in the radiator gives the hand easy access to the bonnet release.
