## Reflections on Lancia 2024

We are talking about a 1.3 Rallye S that we sold to Ireland. The car looks very nice, decent paint, no body filler, so rust underneath, decent dash and seats. The car came from a client of hours, who ran a respectable business, lot of parts were purchased from us, so I was confident the car would be worth the amount requested.

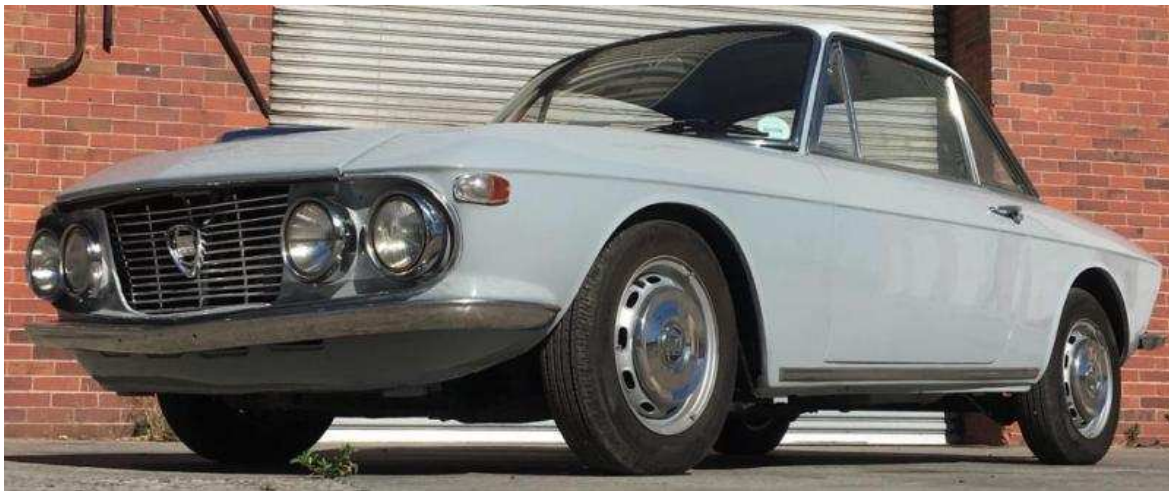
As you can see, the front is low, so we proceeded to change the front spring. In the process I discovered that virtually everything on the car was broken, Brakes, Steering, Suspension, the lot. Any localized repairs seemed impossible, so I ended up ripping everything apart. That despite the fact that the car was supposed to leave for Ireland by the end of 2024. To list all the damages found on the car, would fill volumes. Needless to say, that ALL of them were man-made. The mechanic in charge broke everything possible. The absolute highlight was the brake pipe (not the rubber hose) scraping on the brake disc. Death was certain within a few miles.

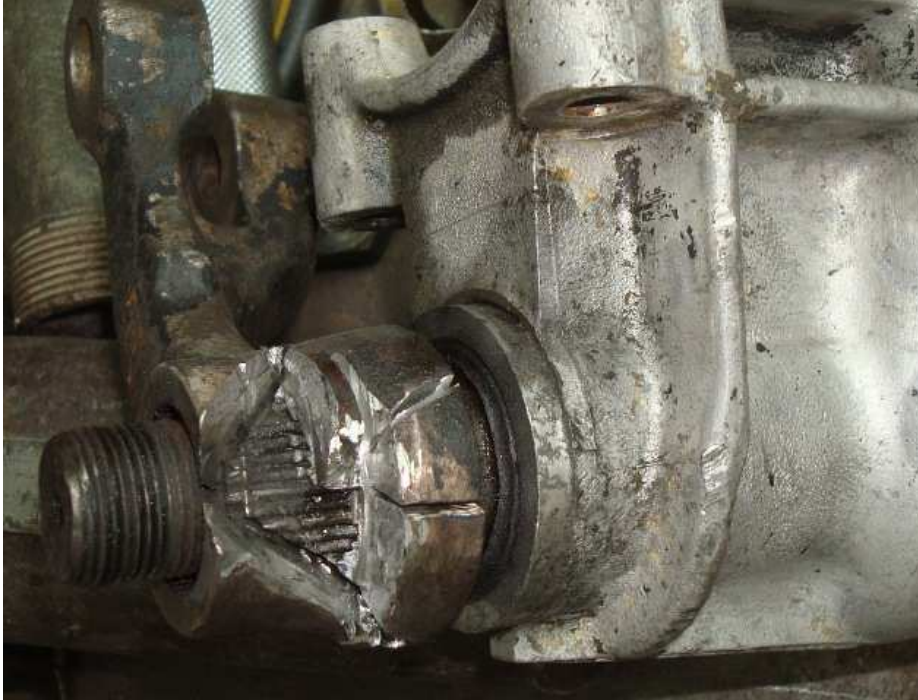
Today I spend my time with the steering box: As you know it is difficult to get the steering arm off, so, we have a special puller made, that so far managed to remove all arms, but not this one. I tried hammering it with large lump hammers, to loosen the fit before applying the puller, but it did not want to budge. As we don't have an oxy acetylene torch, that was the only option left:

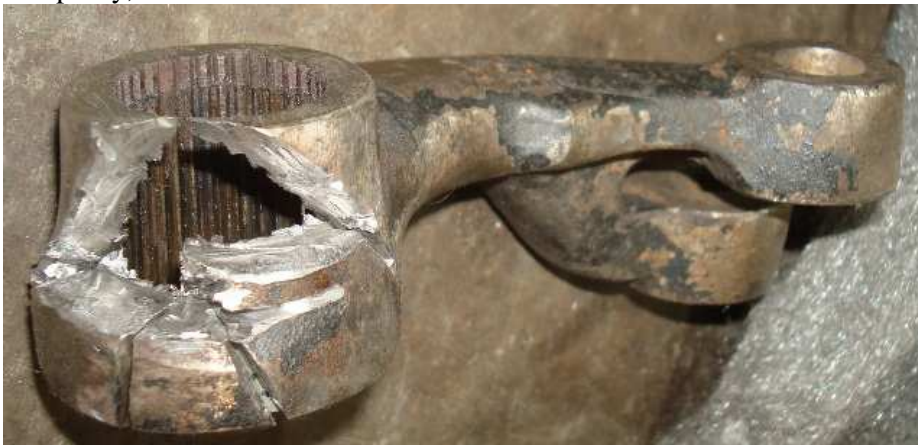
Not pretty, but it came off

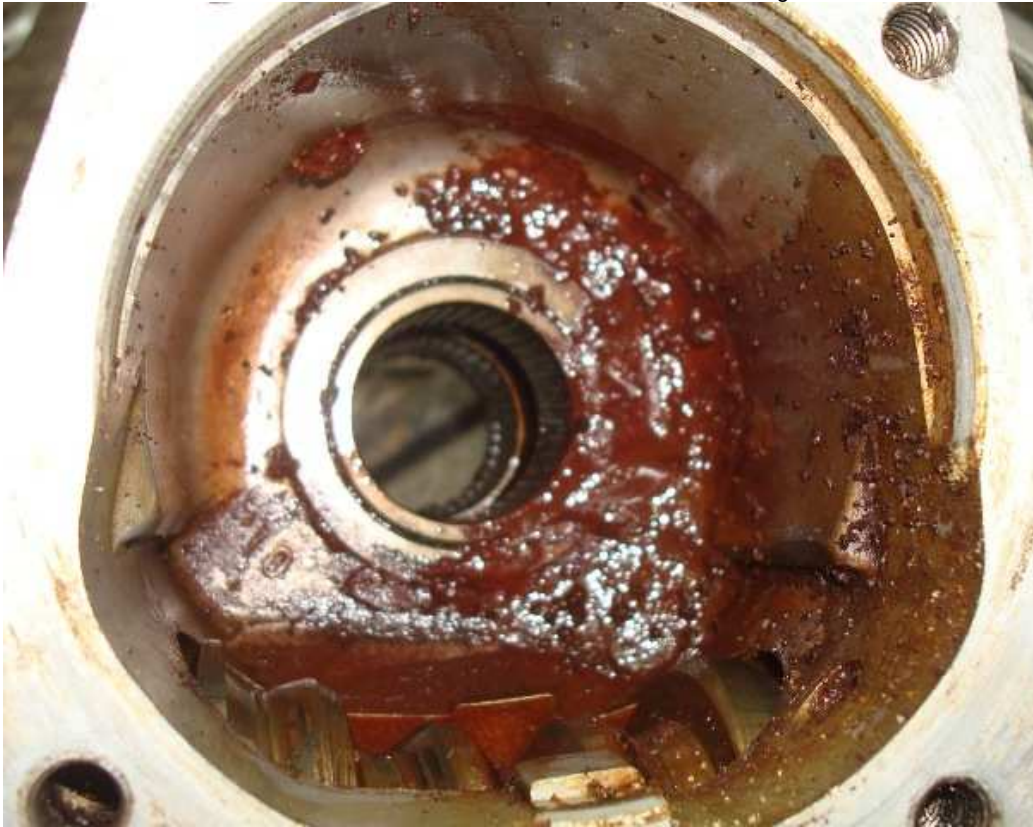
Needless to say, that the box ran dry for decades:

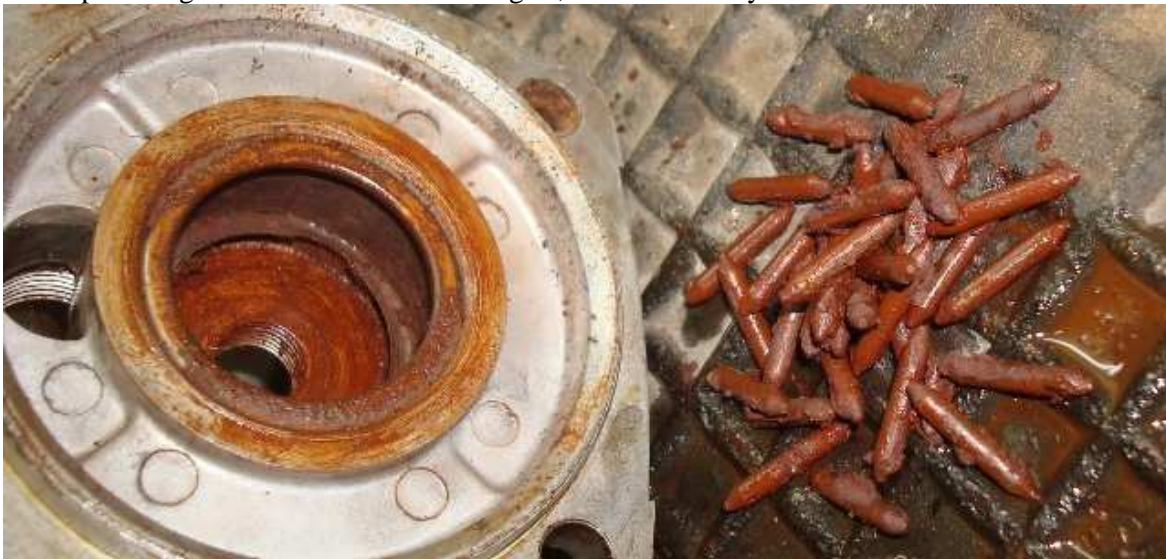
The top bearing of course suffered the longest, so it was totally seized:

As the shops are closed here, I tried to clean it up and reassemble..... but it runs very rough. While I could wait until the bearing supplier opens, the real issue is that the shaft itself is damaged, which would have to be sleeved. Unless I get a shaft from some other steering box,

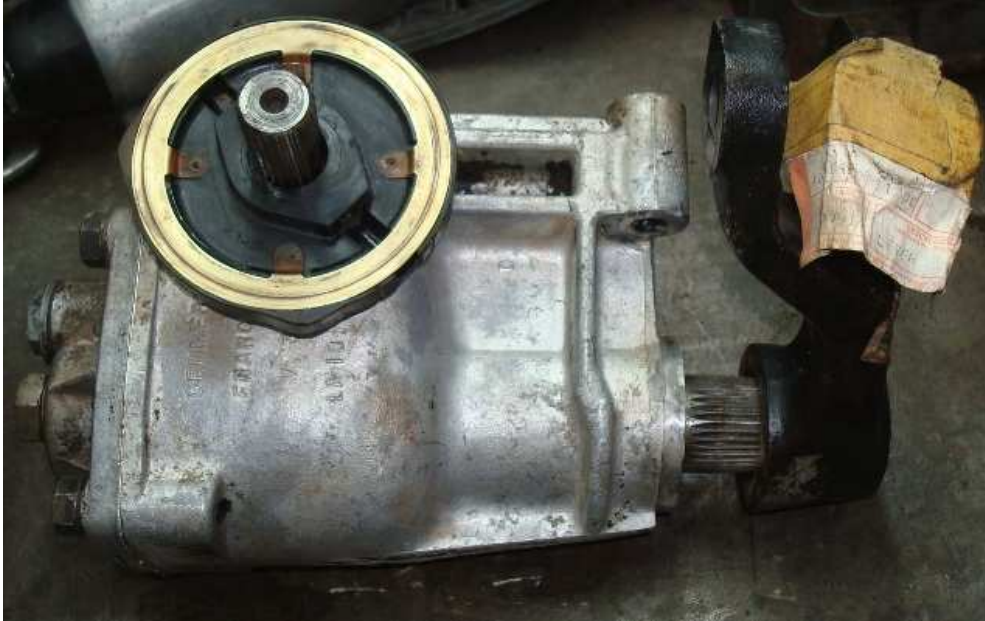
which entails taking off more arms, ouch. The arm could easily be replaced with a new one, accidentally from our first stock clearance we bought in 1993

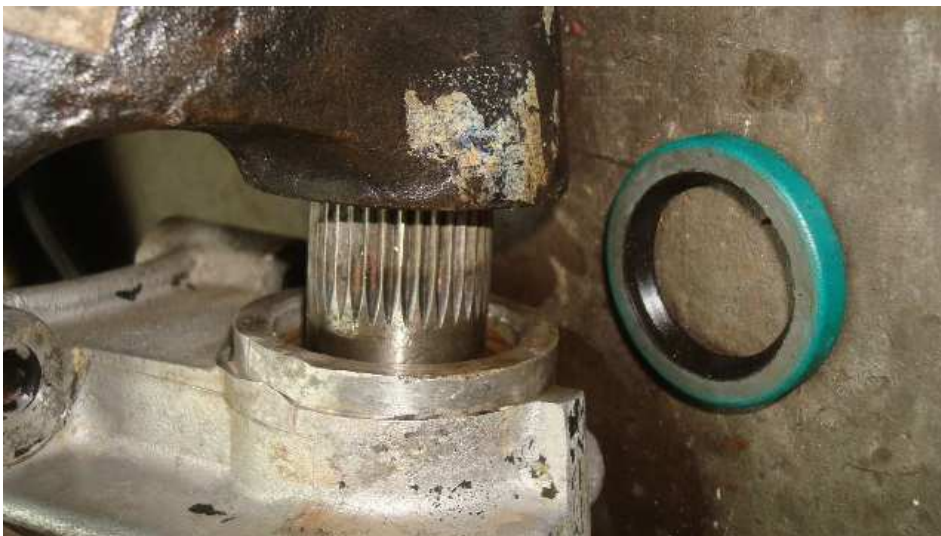
But for some reason, the oil seal which has the correct size of 28.58mm x 39.69mm x 6.35mm Does not want to fit, the hole is only 39mm  
So after sweating the whole day, the job is NOT done:

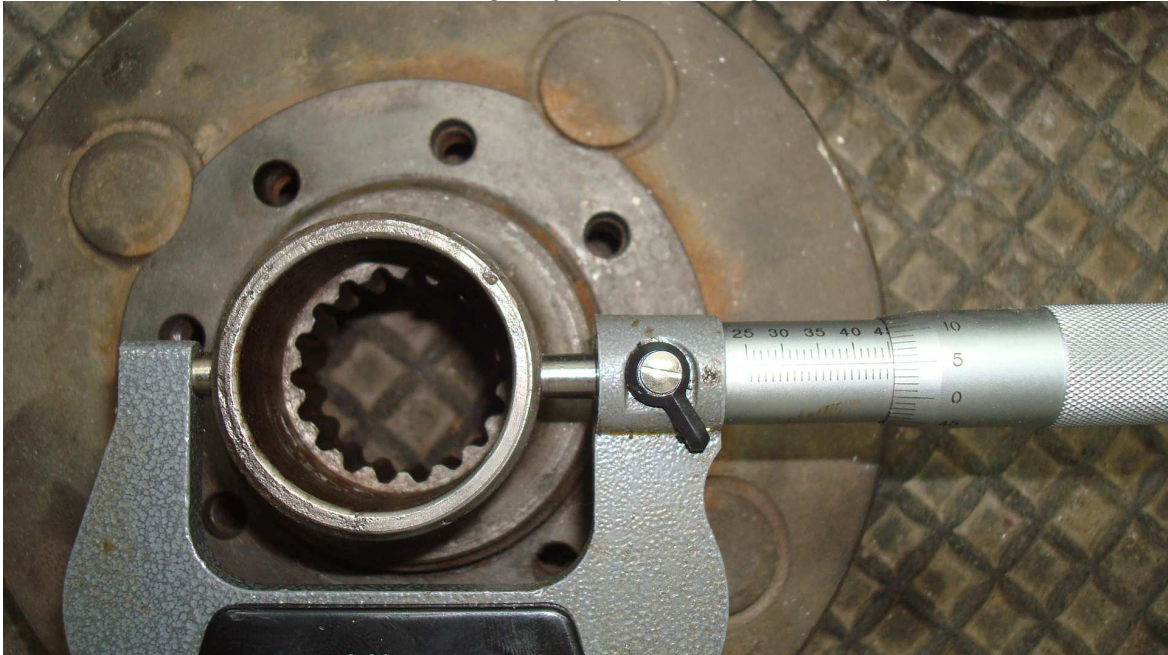
However on this car the mechanic did a good job by increasing the factory diameter:

It is only 0.05 mm difference..... They managed to press the bearing on somehow....  
On removal, the bearing disintegrated. To remove the remaining race took hours it was so tight.  
The details of press/interference fits are something for the engineers, but this one was certainly out of line.....
