From: Lancia Auto ® Sales
Sent: 14 March 2015 01:26 PM
Subject: Lancia Gamma: Drives as good as it looks ?

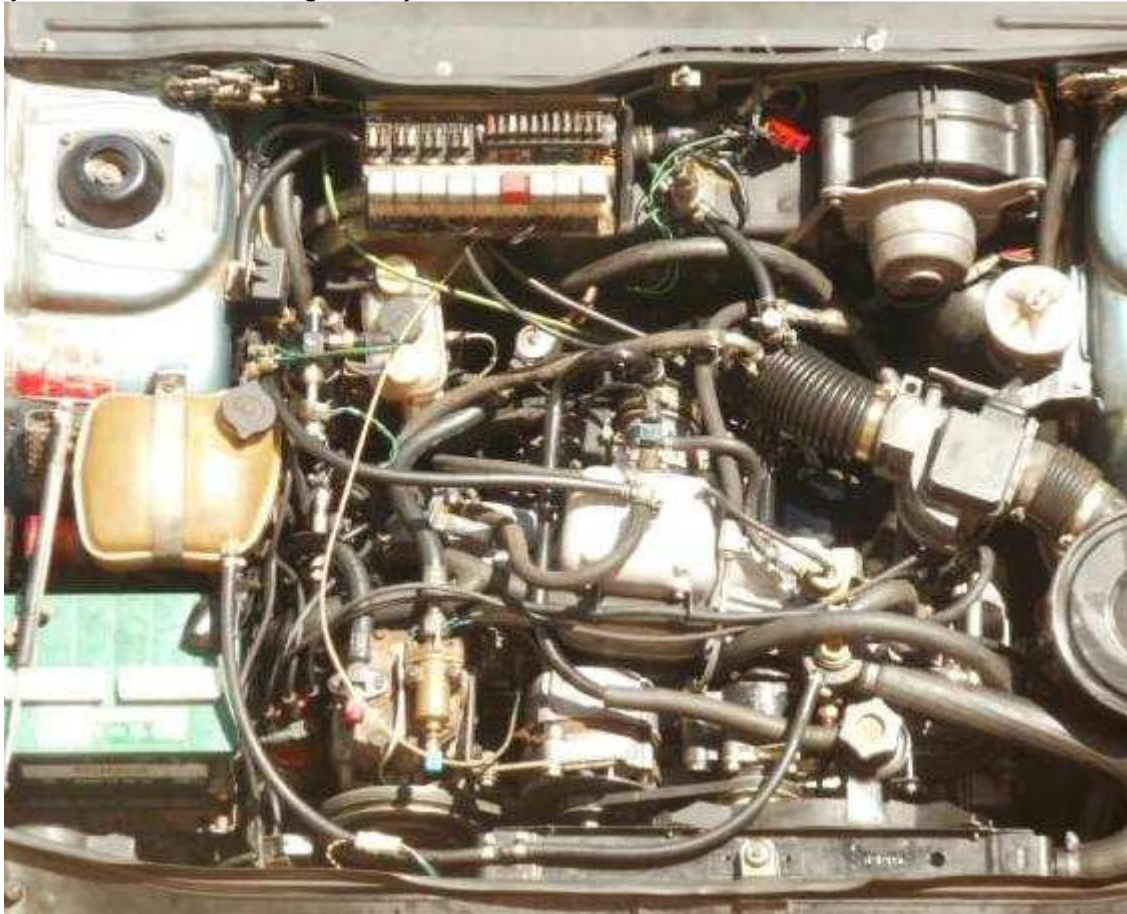
When I showed the first pictures of our Gamma rebuild project, I got some reply from a consortium member that went along the lines of:
 " if it runs as well as it looks.... " This got me seriously worried....
 As you can see here, the engine is by now in the car:

The engine itself seems to be running fine.... it got a new exhaust so it sounds alright, but I never tried to rev it up. You can see in the overall maze of hoses the relocated power steering pump. While reasonably straight forward, the devil was in the detail, a lot of things had to be modified, even the alternator pulley. The radiator had to be moved forward right against the body, both pulley and shaft of the power steering pump had to be flattened to get them away from the fan blades. One club member rightly remarked, that it might be easier just to be careful.... While we only found the aircon condenser to late, we ended up using a Delta condenser which was very similar in construction. To be on the safe side, I did remove the evaporator, which required the removal of the centre console, and was something I regretted. On the other hand, the heater box looked so rotten.... it had to be cleaned.... The car suffers from very low oil pressure reading (only 3-4 bars) however there is a fair chance that the sender unit or even the meter is faulty. Sadly the car it went into was a terrible letdown. it was build up from 2 different Gammas using non lancia seats from some unnamed vehicle. It had a very severe structural front right damage which was only cosmetically repaired. Even the battery tray was

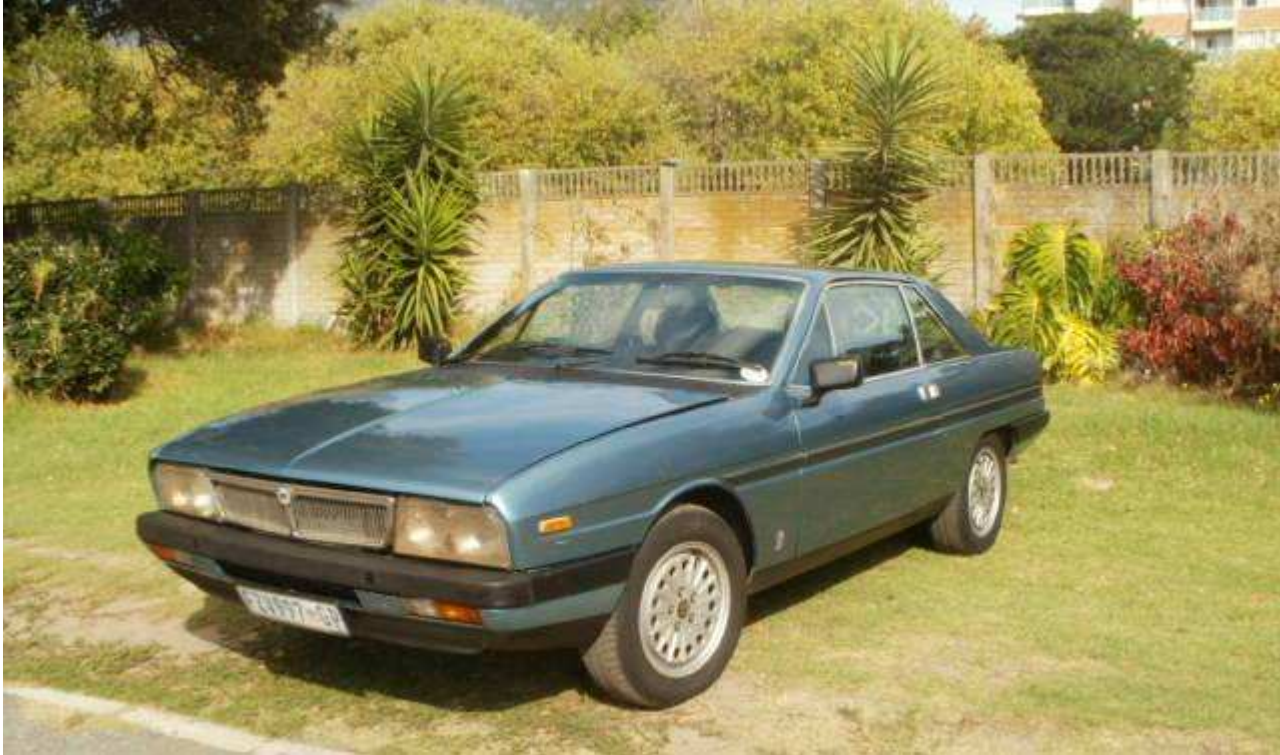
so bend, that you could not fasten the battery.
but after a wash, it nevertheless looked aright:
